QUALIFICATION TEST REPORT FOR
450 GALLON CRASHWORTHY FUEL TANK
FOR
U.S. AIR FORCE H-53 HELICOPTER

APPENDIX B
 QUALIFICATION TEST REPORTS
 QTR-2191
 SECTION N, Q, P, AND R

APPENDIX "B"
QUALIFICATION TEST REPORTS
QTR - 2191
SECTION P
FUEL FIRE TEST

APPENDIX "B"
QUALIFICATION TEST REPORTS
QTR - 2191
SECTION R
LIGHTNING TEST

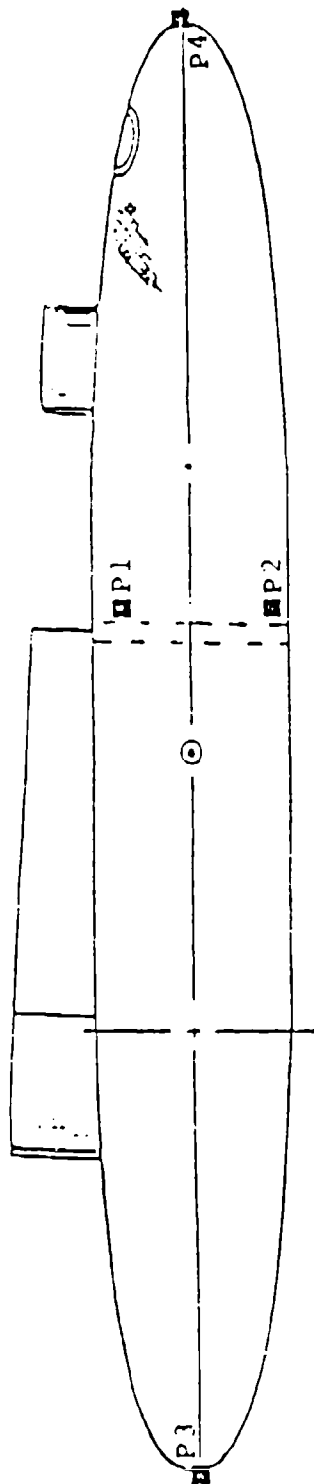
PRESSURE SENSOR LOCATIONS

TABLE 2-2. FUEL VAPOR IGNITION TEST INSTRUMENTATION		
Pressure Sensor Locations		Expected Ranges
Number	Description of Location	PSIA
P1	Through Aft Baffle Access Cover, Measures 6 Inches Below Top Q_L	<180
P2	Through Aft Baffle Access Cover, Measures 2 Inches Above Bottom Q_L	<180
P3	Nose Hole	<180
P4	Tail Hole	<180

The electronic data obtained in this test consisted of internal pressures at four locations, as shown in Table 2-2.

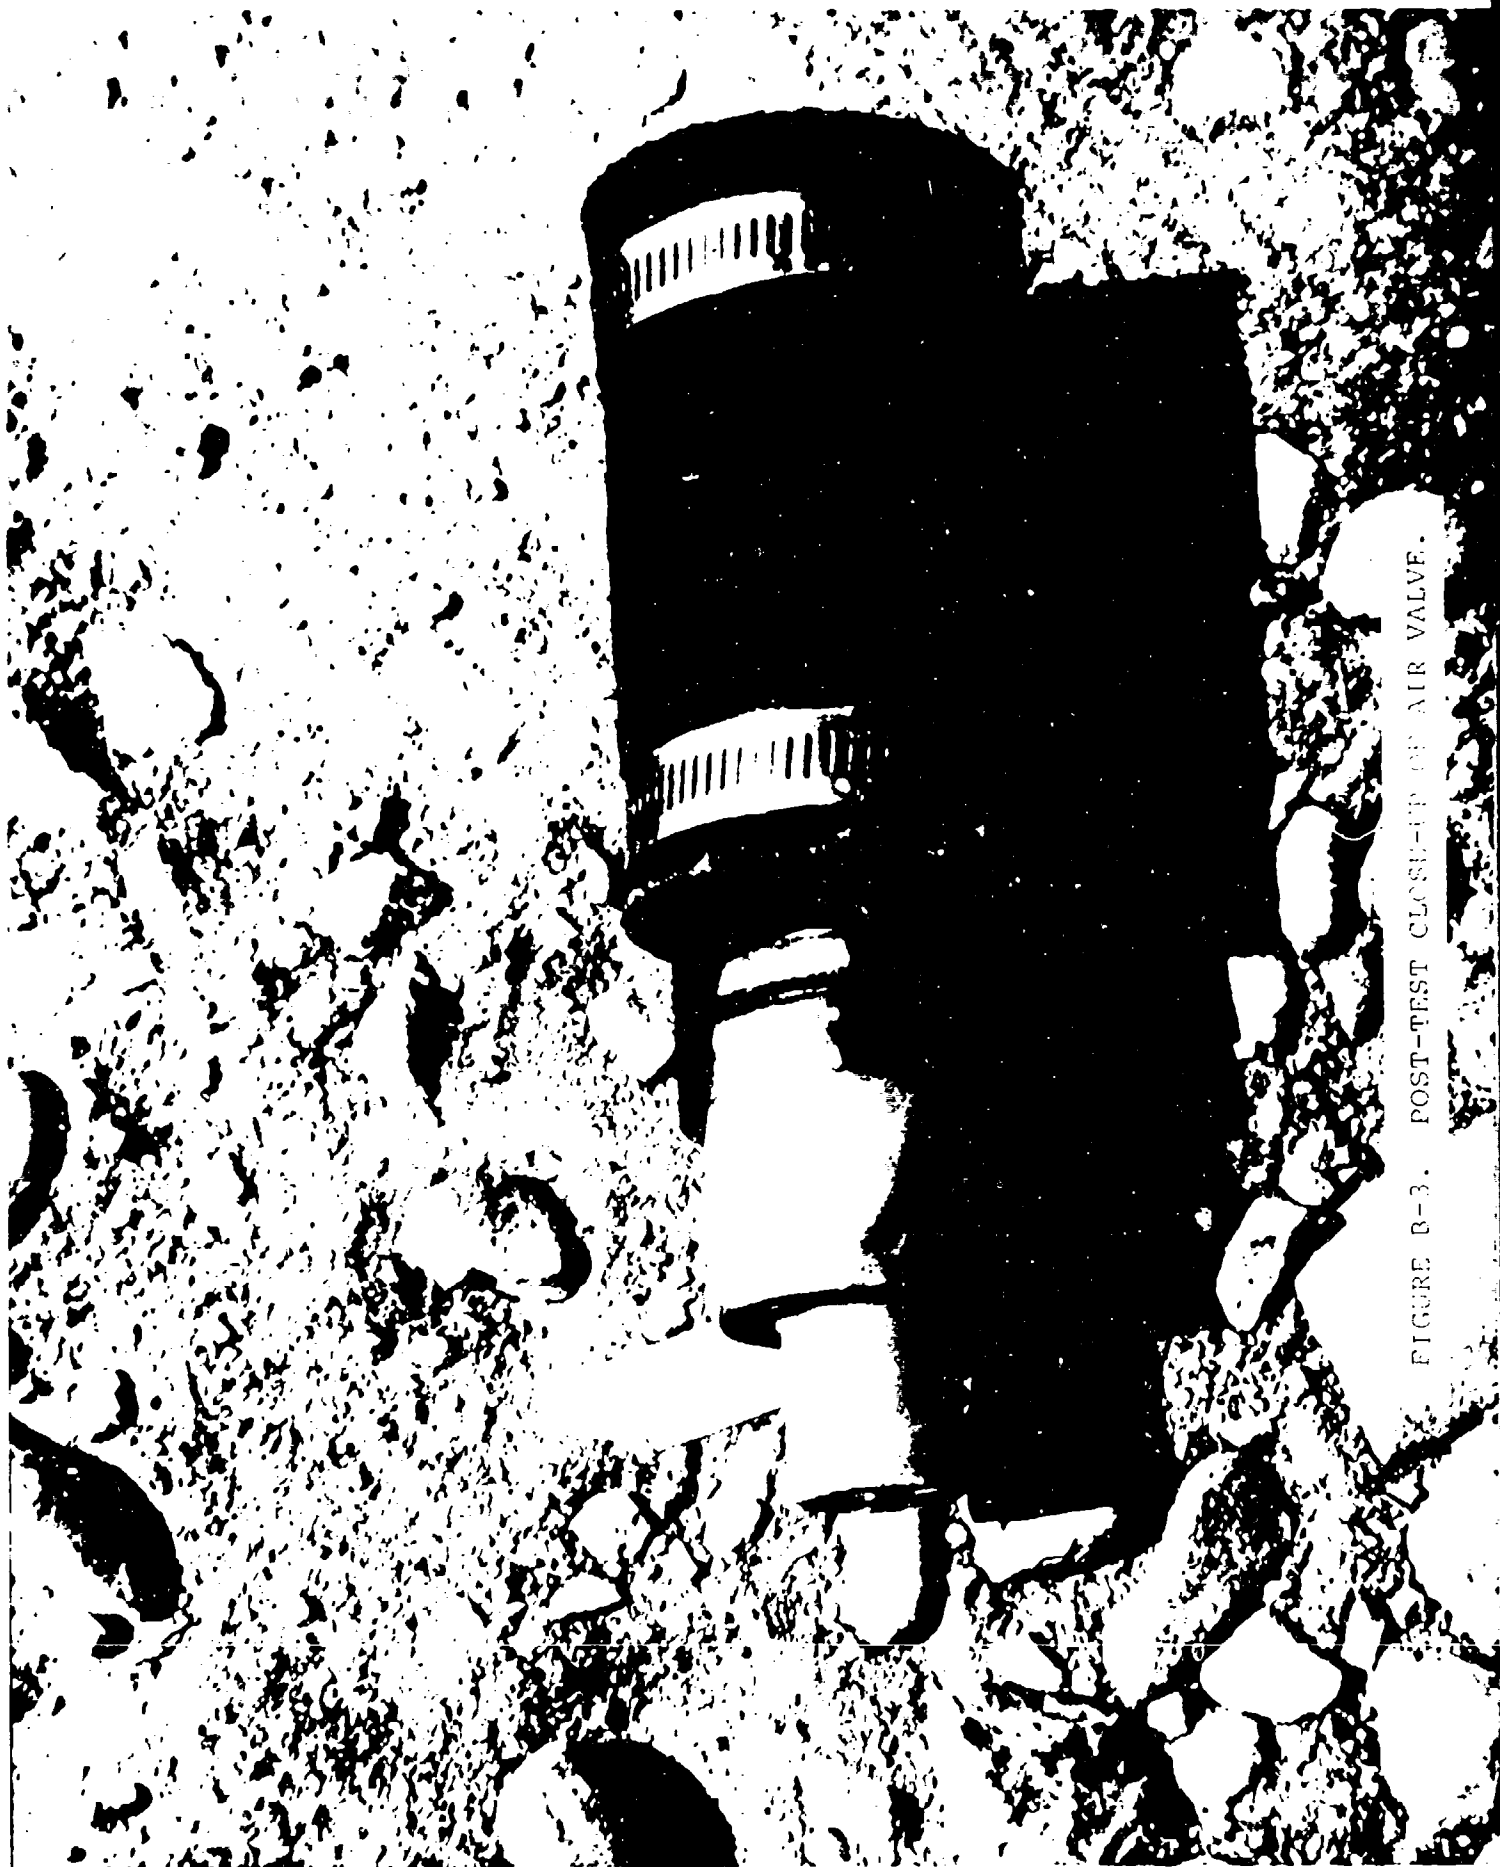
FIGURE B-3. POST-TEST CLOSE-UP OF AIR VALVE.

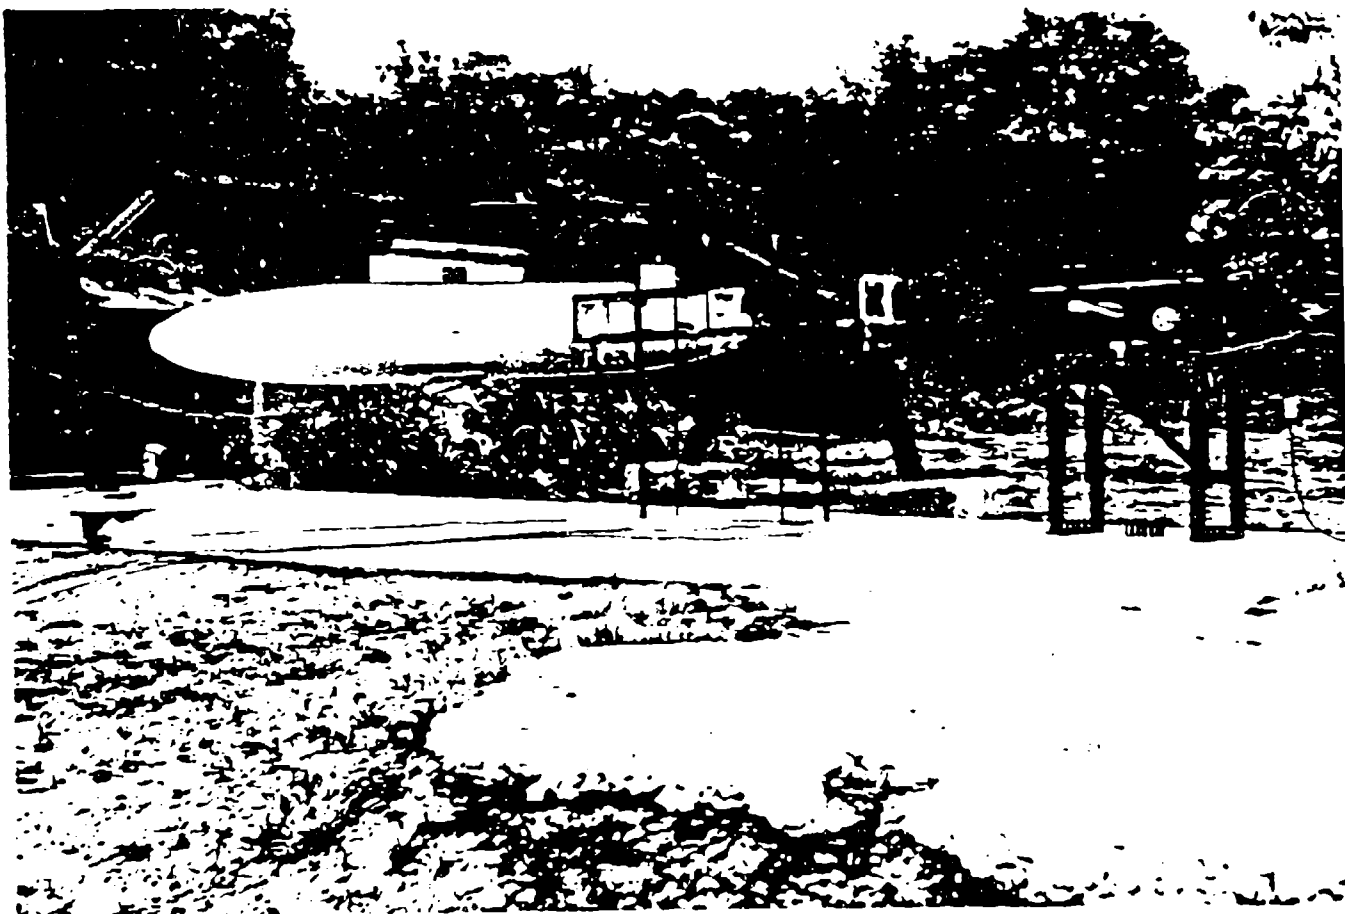
Figure 1. Test Installation

Right to Left: Mann Gun, Chronograph Screen Array, and Fuel Tank

(1) a chronograph system consisting of a chronograph screen array, seen in Figure 1 between the Mann gun and the fuel tank, and three electronic counters located in the instrumentation room. The chronograph screens were two sheets of aluminum foil separated by waxed paper which when perforated by the metallic projectile closed an electric circuit. Three of these screens were mounted on wooden frames attached to a steel rack so that the screens were spaced exactly at four foot intervals. Each screen was wired in a circuit with a 9 volt battery to a start and/or stop input of an electronic counter. The electronic counters were Hewlett Packard Model 5315A Universal Counters. The screen closest to the Mann gun was connected to the start inputs of Counters 1 and 3. The center screen was connected to the stop input of Counter 1 and to the start input of Counter 2. The last screen was connected to the stop inputs of Counters 2 and 3. This screen was intended to provide redundancy in determining the projectile velocity. The first screen was located three feet from the muzzle of the Mann gun; the fuel tank was 16 feet from the Mann Gun muzzle. The screens were spaced within $\pm 1/8$ inch. The counters can determine the elapsed time within ± 0.0000002 sec. The data reduction technique used corrected for the change in projectile attitude at each screen encountered. The accuracy of the projectile velocity determination is ± 18 ft/sec.

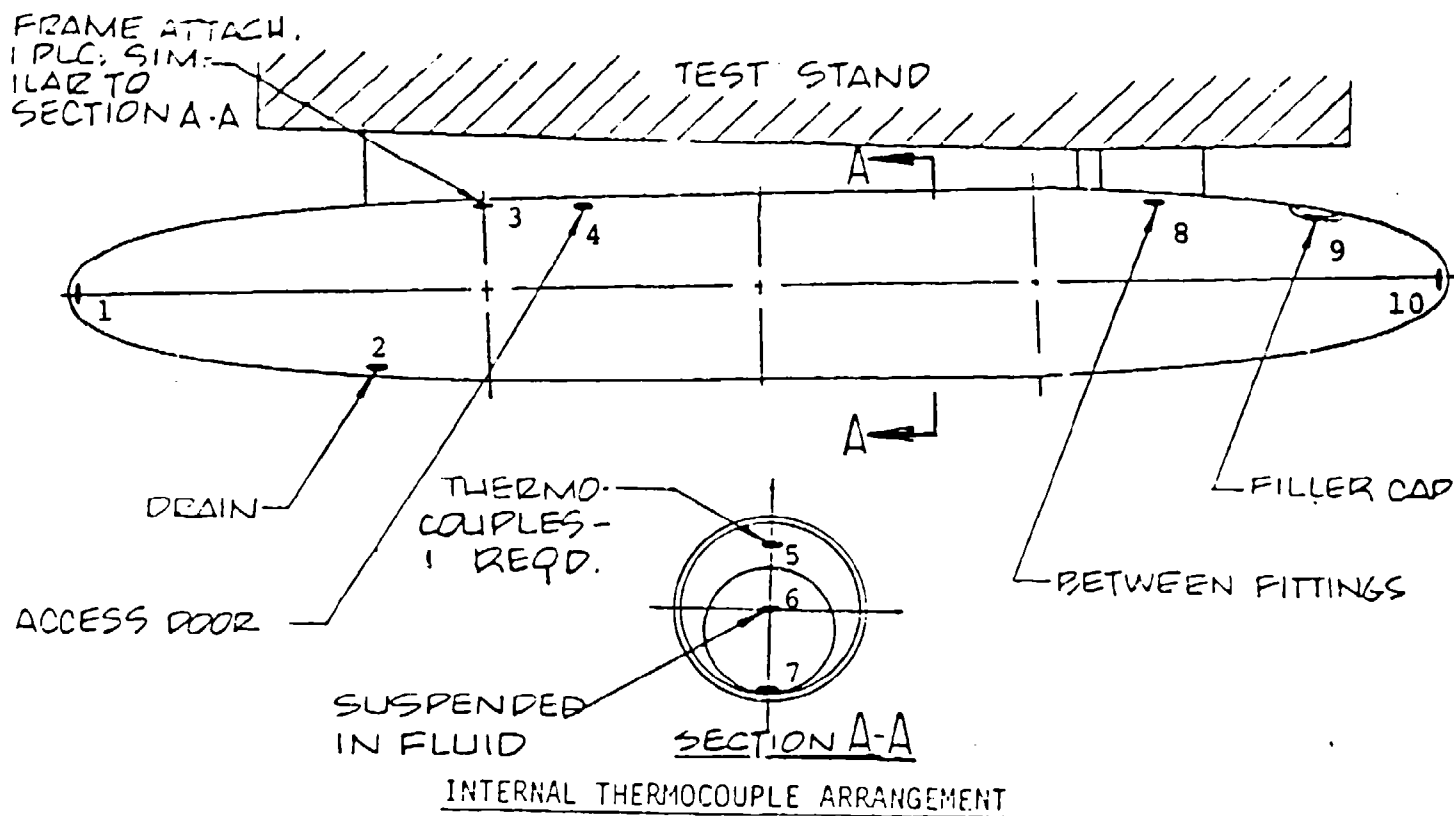
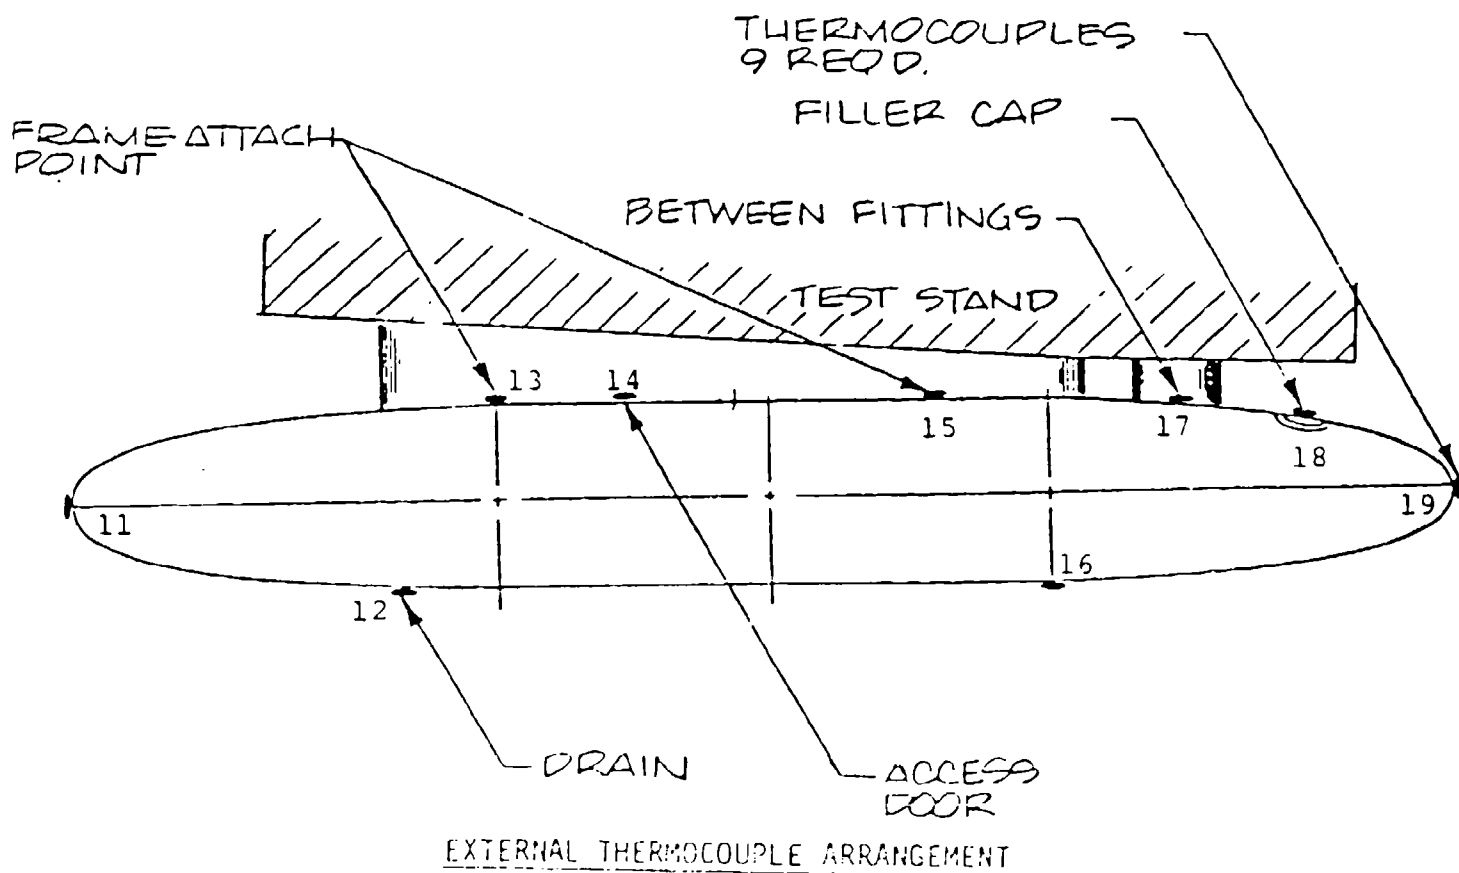
FIGURE 2-1. FUEL FIRE THERMOCOUPLE LOCATIONS.

The electronic data obtained in this test consisted of temperatures measured by ten internal and nine external thermocouples, as shown in Figure 2-1 and Table 2-2.

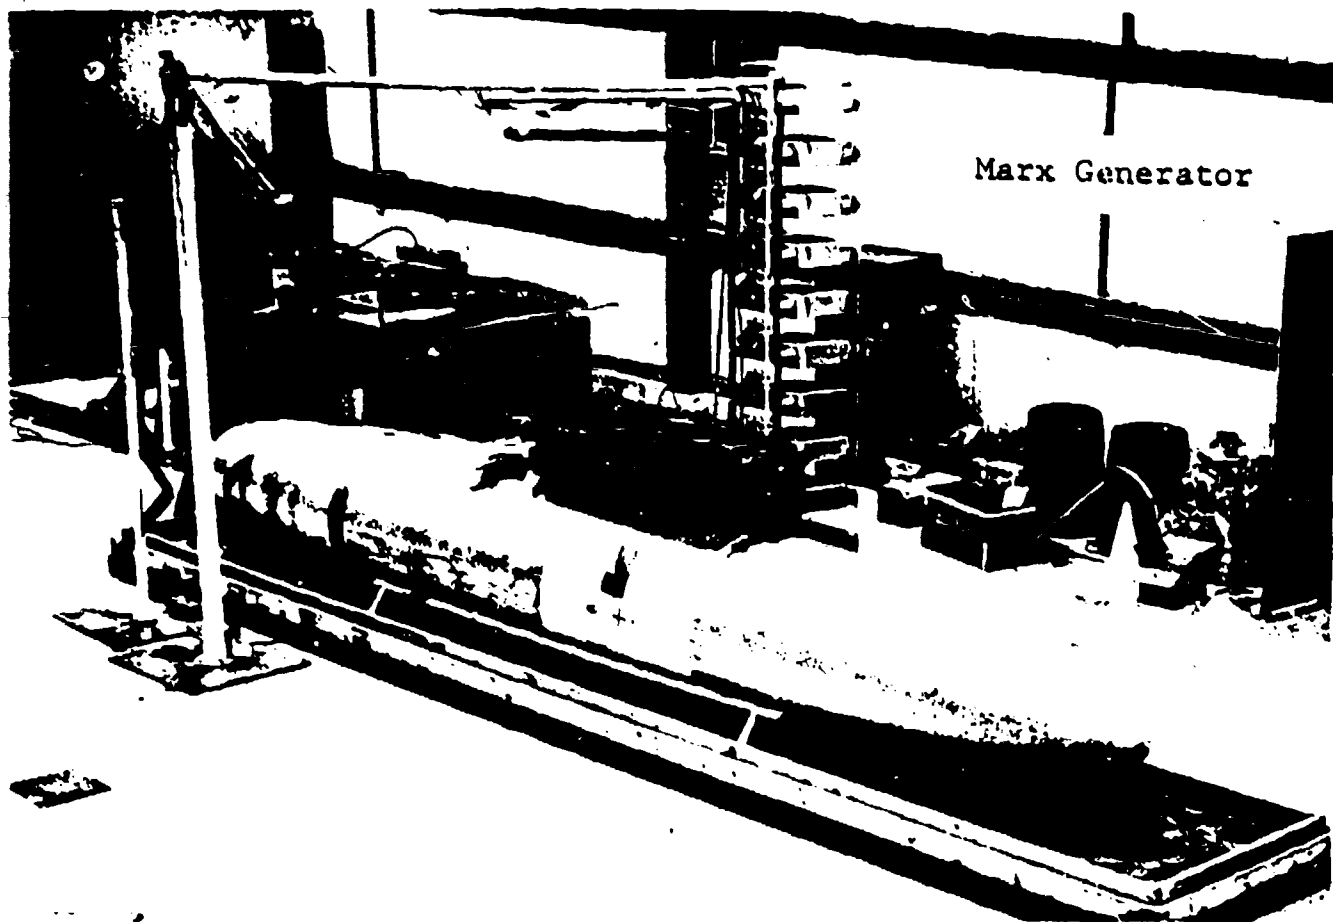
Figure 1 - Test Setup for Lightning Strike Attachment Tests.

Simulated lightning strike attachment tests (also called high voltage tests) were performed first to determine detailed lightning strike attachment points, and especially, to determine if metallic objects on the tank, such as the drain valve, would attract strikes. The tank was initially positioned with the high voltage electrode adjacent to the drain valve at a distance of 12". The pylon was connected to the generator ground circuit. A 475:1 resistive voltage divider in conjunction with a Tektronix 544 oscilloscope was used to measure the voltage applied between the test electrode and the fuel tank. A Polaroid-type camera was positioned so that its lens entered the interior of the tank through the filler cap opening near the pylon. Any light detected by the camera during testing would be indicative of interior sparking. Figure 1 shows the tank in position for the lightning strike attachment tests.

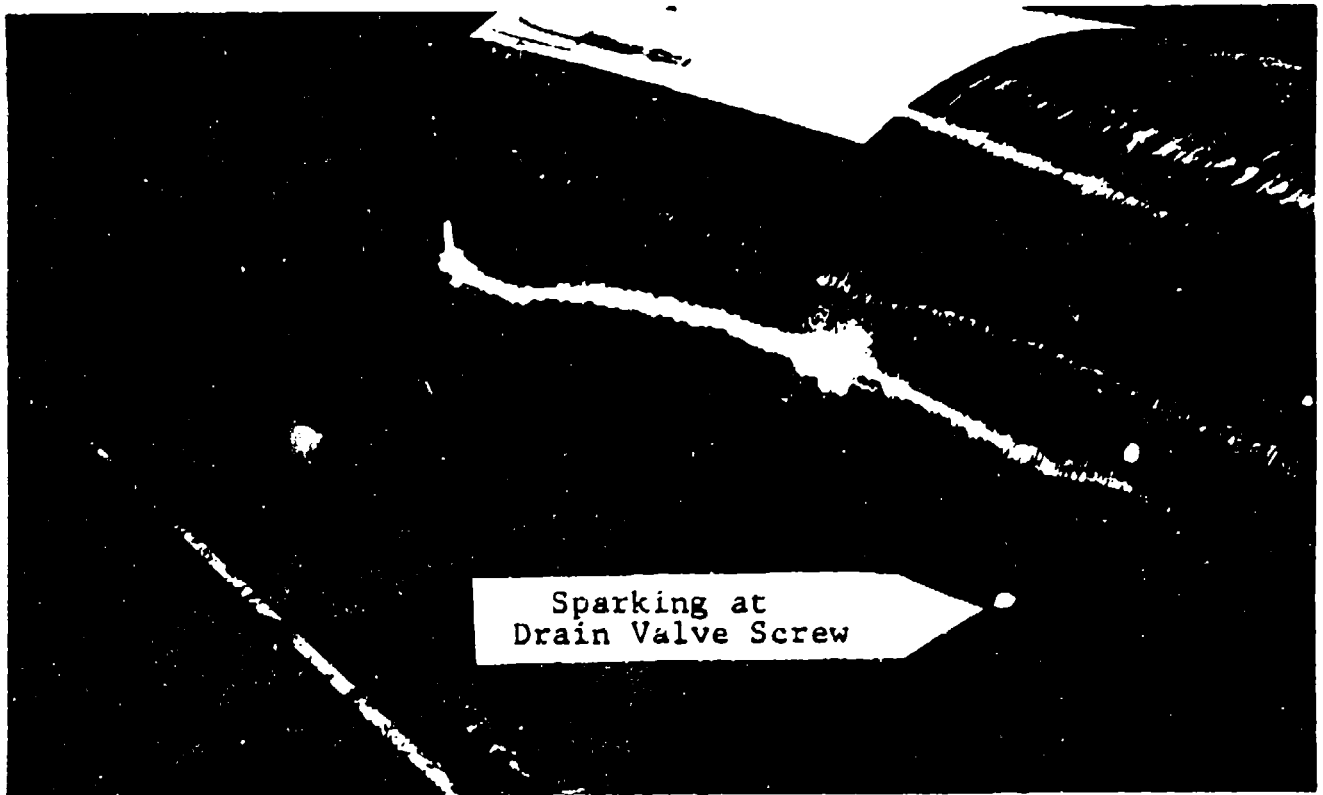
Figure 4 - Lightning Strike Attachment Test No. 4. Flashover to Composite Skin.

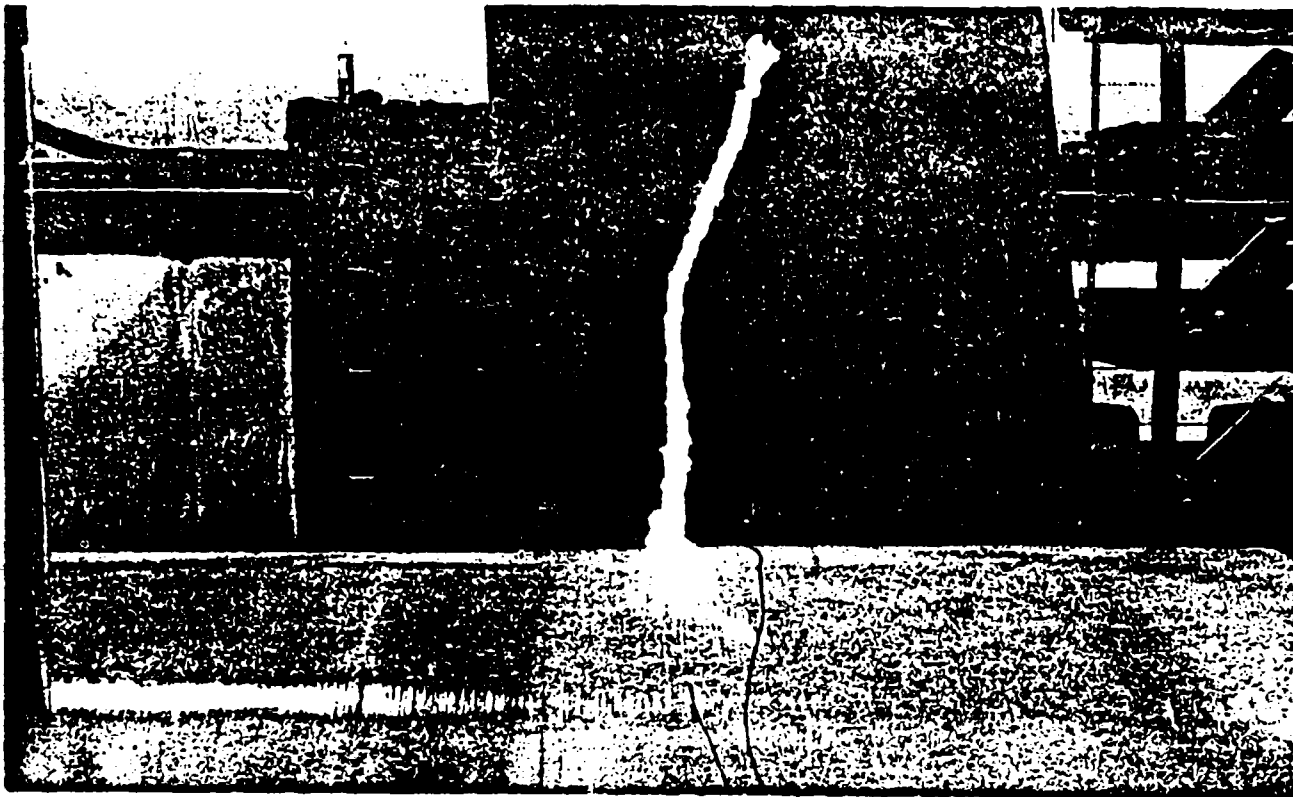
Figure 9 - Lightning Strike Attachment Test No. 16. Flashover to Area Several Inches Forward of Ring.

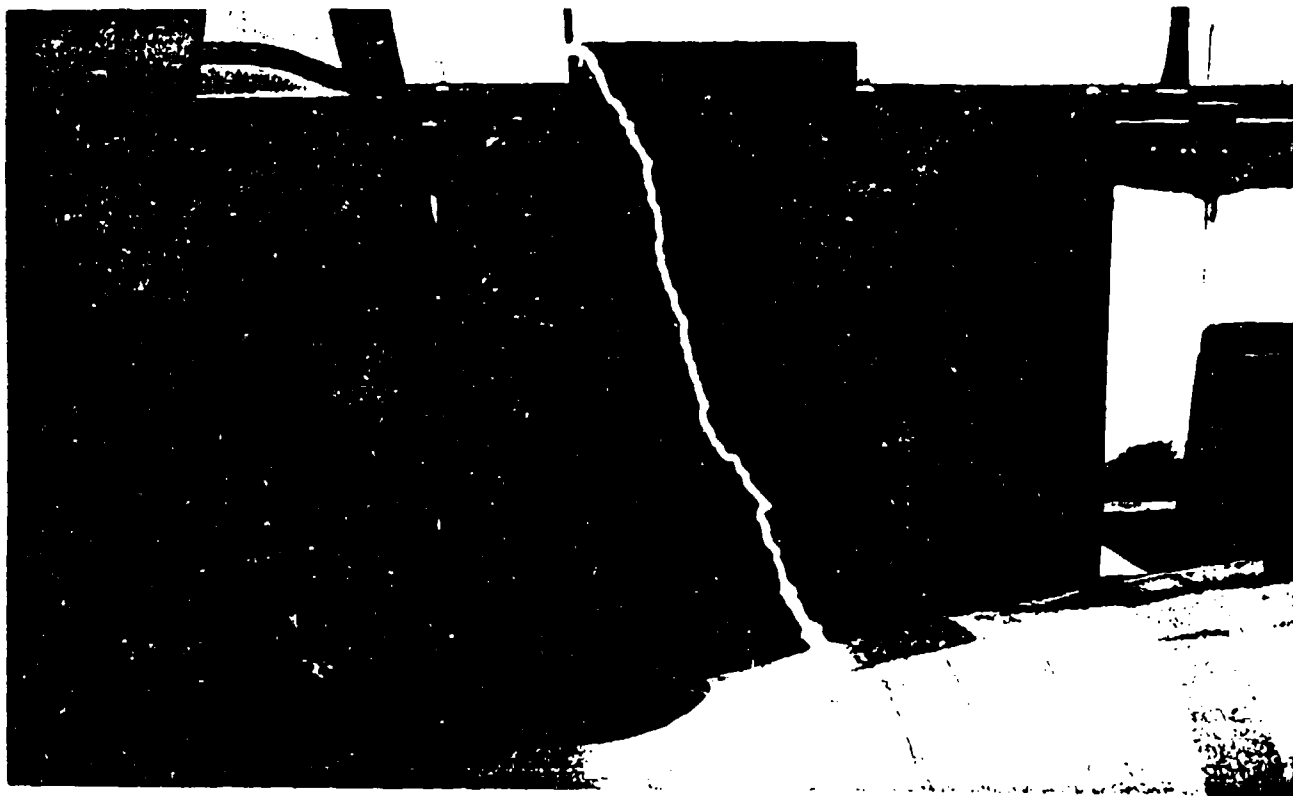
Figure 10 - Lightning Strike Attachment Test No. 18. Flashover to Label.

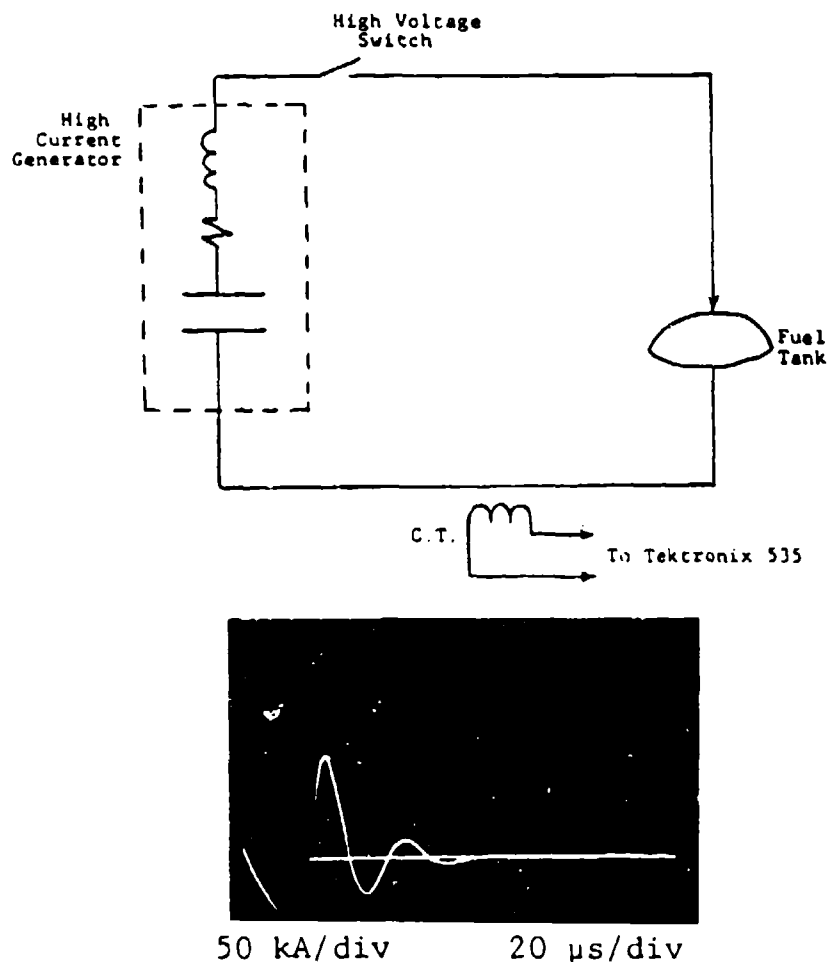
Figure 12 - Test Circuit Schematic and Typical Oscillogram of Applied Current for Simulated Lightning Damage Tests.

A 17 μF , 50 kilojoule capacitor bank was used to generate the test currents. The electrode was placed in contact with the tank at several locations during the test. The test circuit schematic and typical input current are shown in Figure 12.

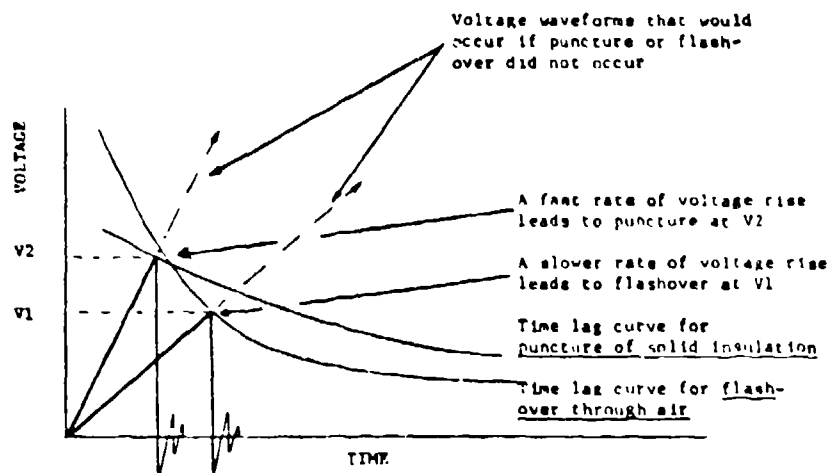
Figure 3-1 Influence of rate of rise on flashover path

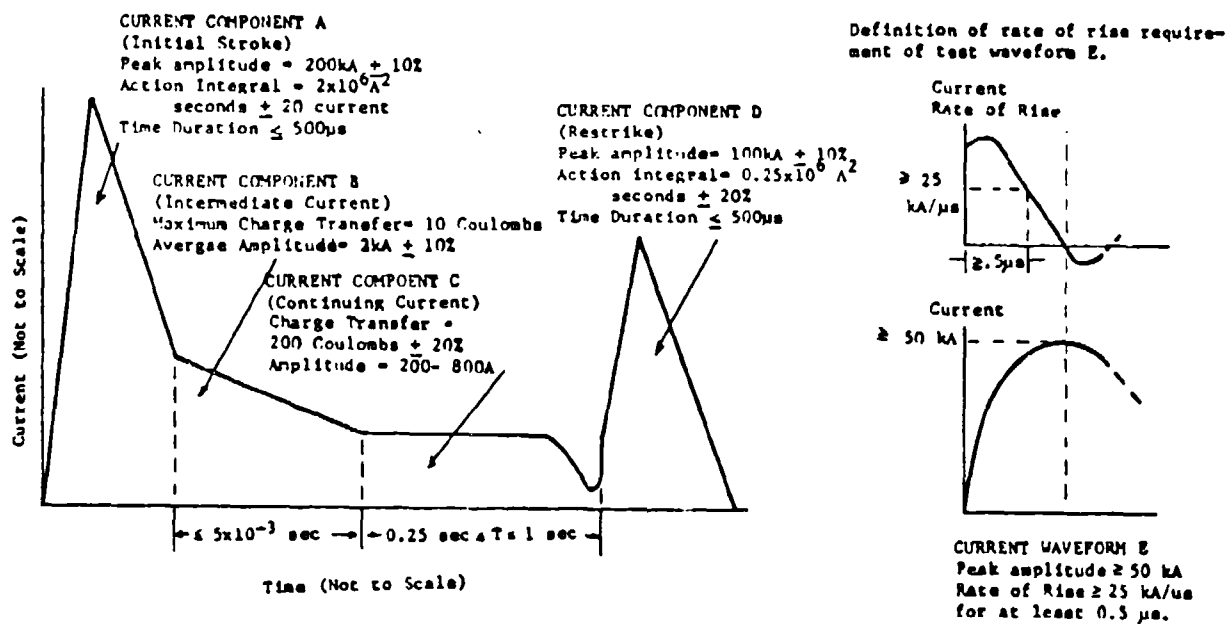
Figure 3-3 Idealized current test waveform components for qualification testing.

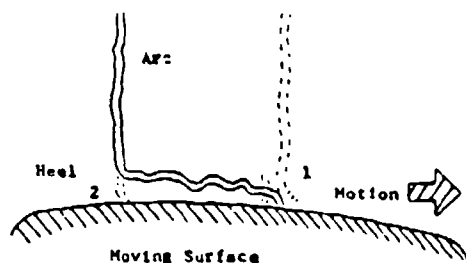
Figure 4-3 Basic mechanism of swept stroke attachment.

The arc will again be blown back along the surface until the voltage along the arc channel and arc-metal interface is sufficient to cause flashover and attachment to another point. The voltage at which each new attachment will occur depends strongly upon the surface finish of the object under test. The voltage available to cause puncture depends upon the current flowing in the arc and the degree of ionization in its channel. There is an inductive voltage rise along the arc as rapidly changing currents flow through it. There will also be a resistive voltage rise produced by the flow of current. The inductive voltage rise as well as the resistive rise can be quite significant when a lightning restrike occurs at some point in the flash.

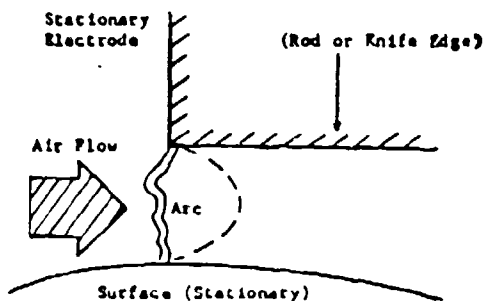
Figure 4-5 Arc moved relative to stationary test surface.

The test electrode should be far enough above the surface so as not to influence the arc attachment to the test surface. If the technique of Figure 4-5 is used, the electrode should be a rod parallel to the air stream and approximately parallel to the test object.
